# ARCHAEOLOGICAL EXCAVATION.

## 18-20 CLARENCE STREET, PORT MACQUARIE. OPEN DAY, SATURDAY, 8 SEPTEMBER 2007.

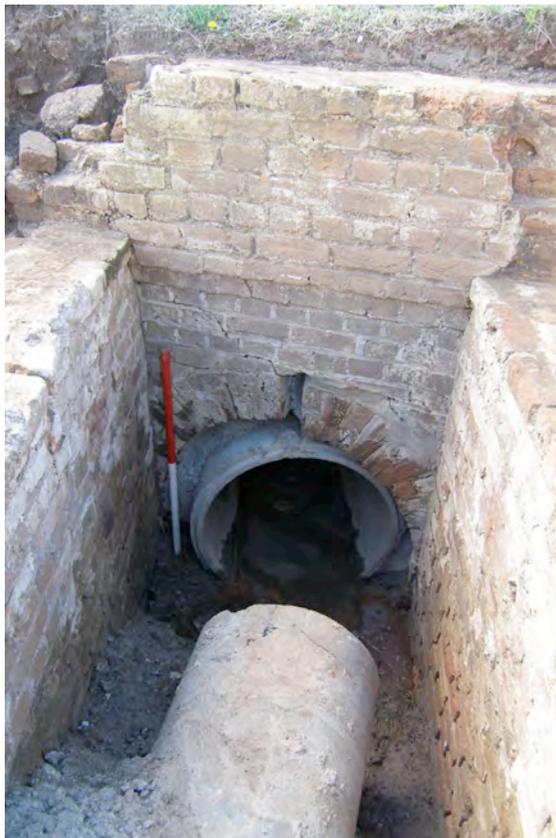
The upper end of the brick barrel drain on Clarence Street, with the headwalls and wingwalls intact.

#### 5. The Brick Barrel Drain.

The drain across Clarence Street was built in the 1830s, as the street was laid out for the new town. We know the date because the headwall of the drain is parallel with Clarence Street, and not the earlier street layout.

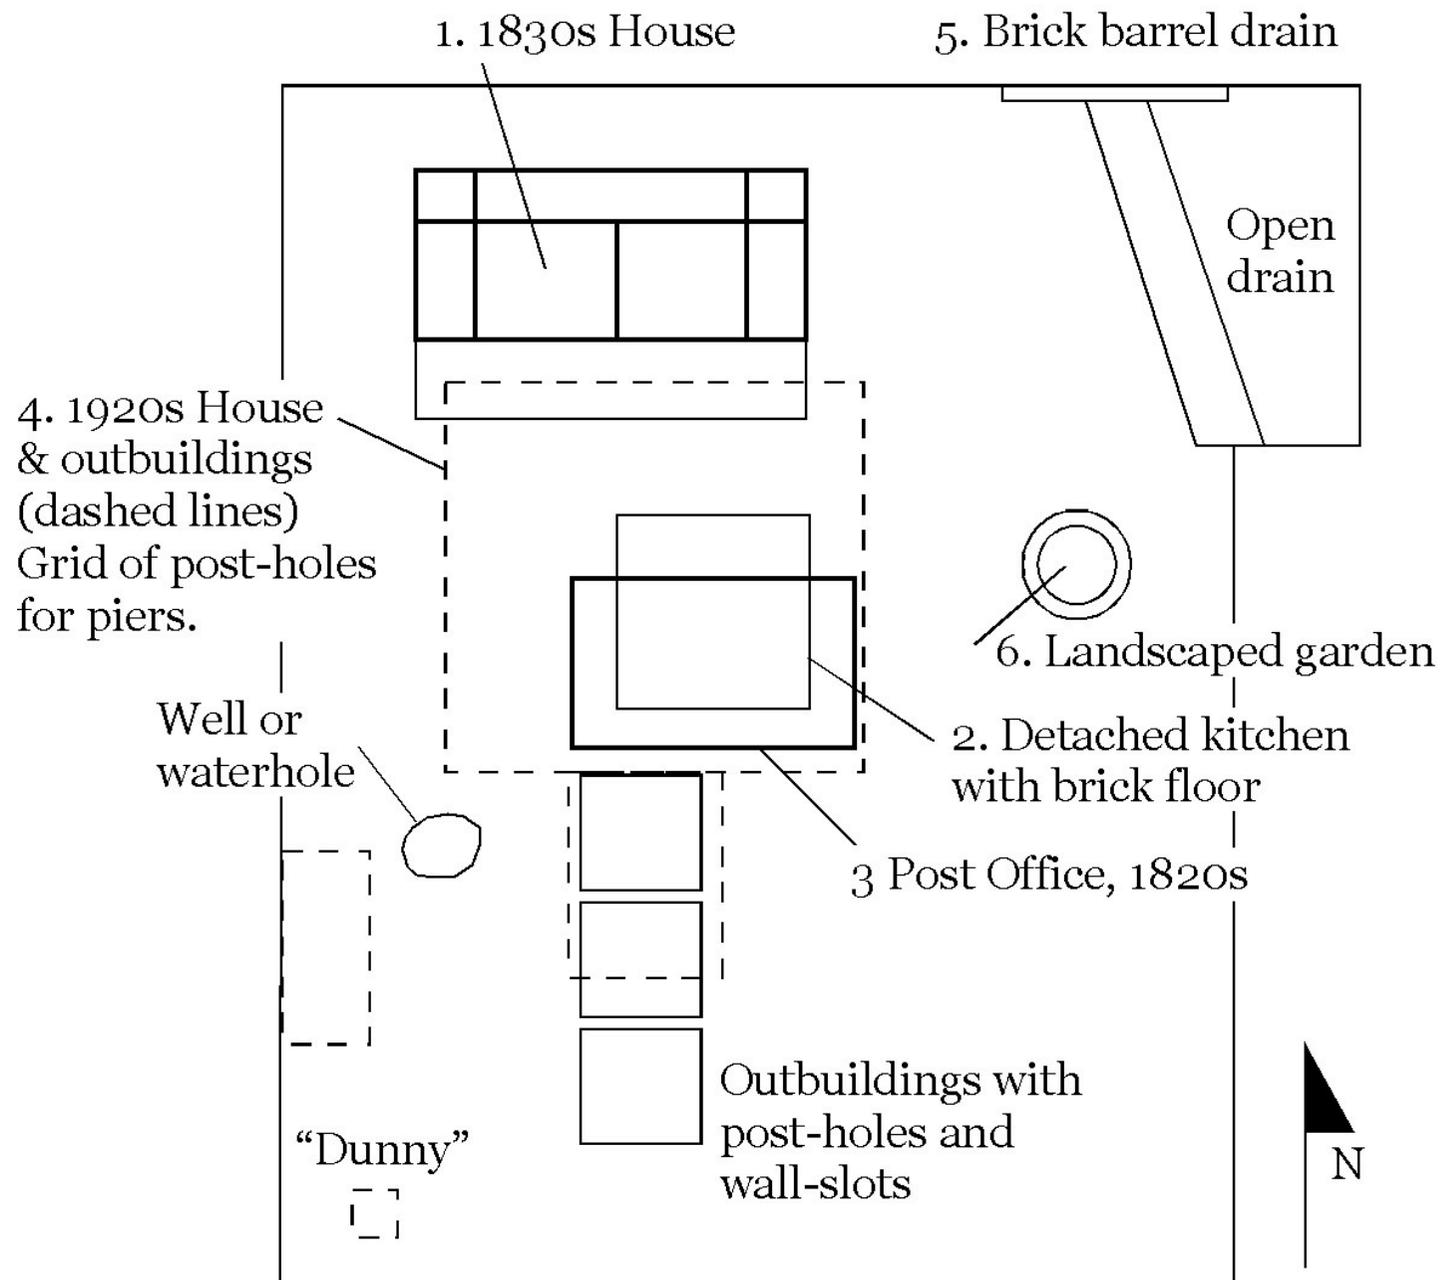
We have found a series of structures (see plan overleaf for numbered items).

#### 1. The 1830s house.

We have located the footings of the 1830s house on the Clarence Street frontage. The building has two large rooms, fireplaces and then smaller verandah sized rooms.

#### 2. Detached kitchen.

Behind the 1830s house, the site of the detached kitchen is marked by a brick floor.

#### 3. Post-Office, 1820s.

The earliest structure on our site has also been the most elusive. We believe the Post Office

building, shown on the 1826 map is located directly beneath the brick floor of the detached kitchen. The wall lines are marked by wall slots in the soil. These originally held the timber wall members of the early structure.

#### 4. The 1920s house.

The timber framed house was supported on rows of timber piers. The regular layout of post-holes can be easily seen behind the 1830s house.

#### 6. A landscaped garden.

It is not often that we find garden landscape features. Here we have a series of brick lined and rubble surfaced pathways around a circular garden, probably a formal rose garden or similar style of planting.
