OPEN DAY – 10 JUNE 2006.

**ARCHAEOLOGICAL
EXCAVATION.
PROPOSED ARTS,
ENTERTAINMENT &
CONFERENCE CENTRE,
CLARENCE STREET, PORT
MACQUARIE.**

Brochure No. 2.
For historical background, see Brochure No. 1.

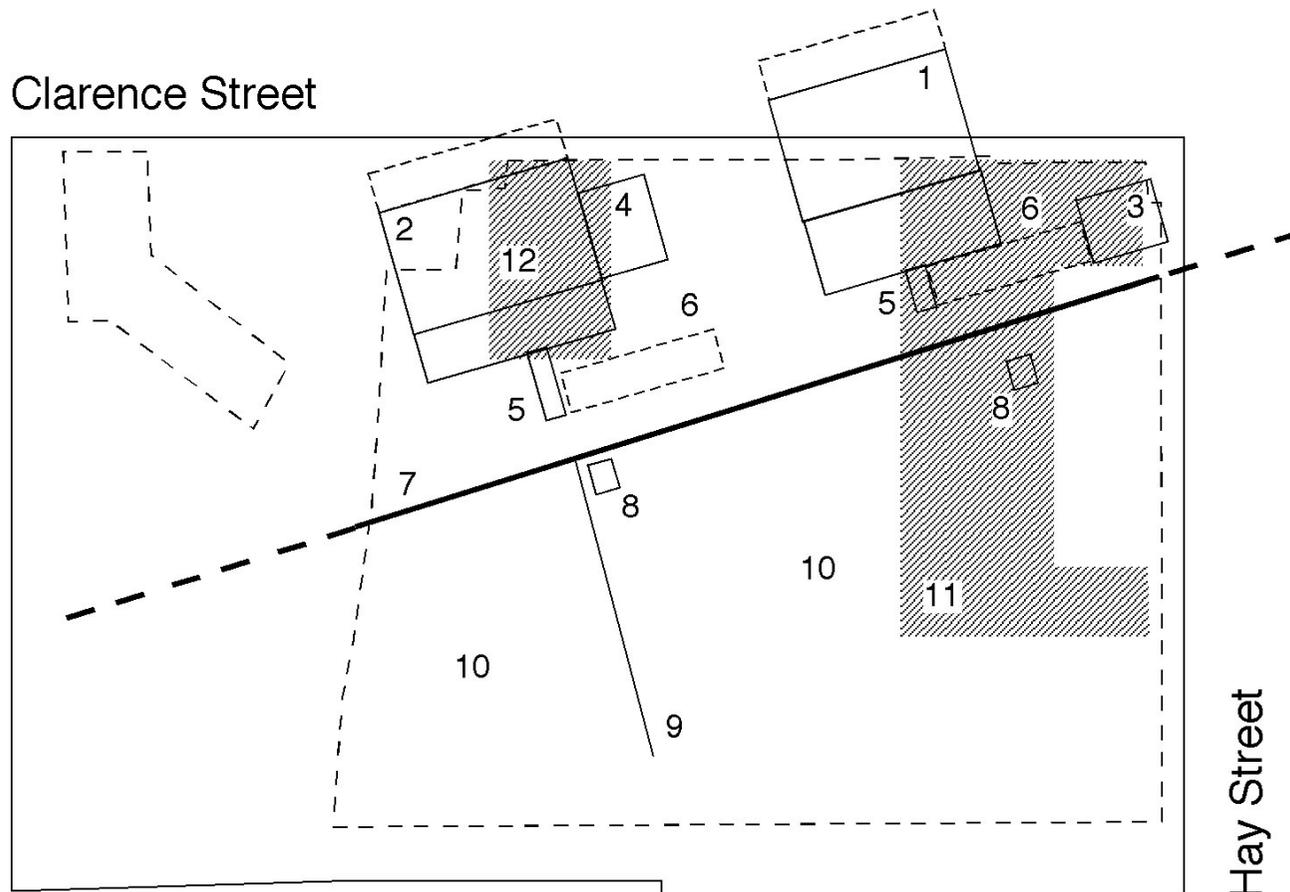
Key.

The excavation is now in its final stages after four weeks of work. So, what have we found? The principal features of the site can be seen on the sketch plan opposite.

1. Free Overseer's Cottage No. 2, and
2. Free Overseer's Cottage No. 3, both with front verandahs and back skillions (lean-to structures).
3. Post-built structures (bark huts?).
4. Extension to Cottage No. 3.
5. Brick paved pathway.
6. Site of outbuildings.
7. Brick barrel drain.
8. Timber lined pit.
9. Fenceline in Kitchen Garden Allotments.
10. Kitchen Garden Allotments.
11. School of Arts (1884), shaded.
12. Town Hall (1892), shaded.

The houses originally had brick footings – only short sections of brickwork now survive. When the houses were demolished, most of the brick was salvaged for use elsewhere around the town. We have dug out the footing trenches and recovered the occupation materials from within each room. We can see that the houses had a central hallway, flanked on each side by two rooms.

Each house is different. Cottage 3 had larger rooms than Cottage 2, but Cottage 2 had a larger lean-to addition at the rear. The houses fronted onto Henrietta Street, which was replaced by Clarence Street in 1830, hence the houses are at a slight diagonal.

Behind is a brick pathway, leading to the kitchen garden allotments for each house. We have also found evidence of outbuildings.
