MUCH ADO ABOUT MORTAR

– recent archaeology at Elizabeth Farm

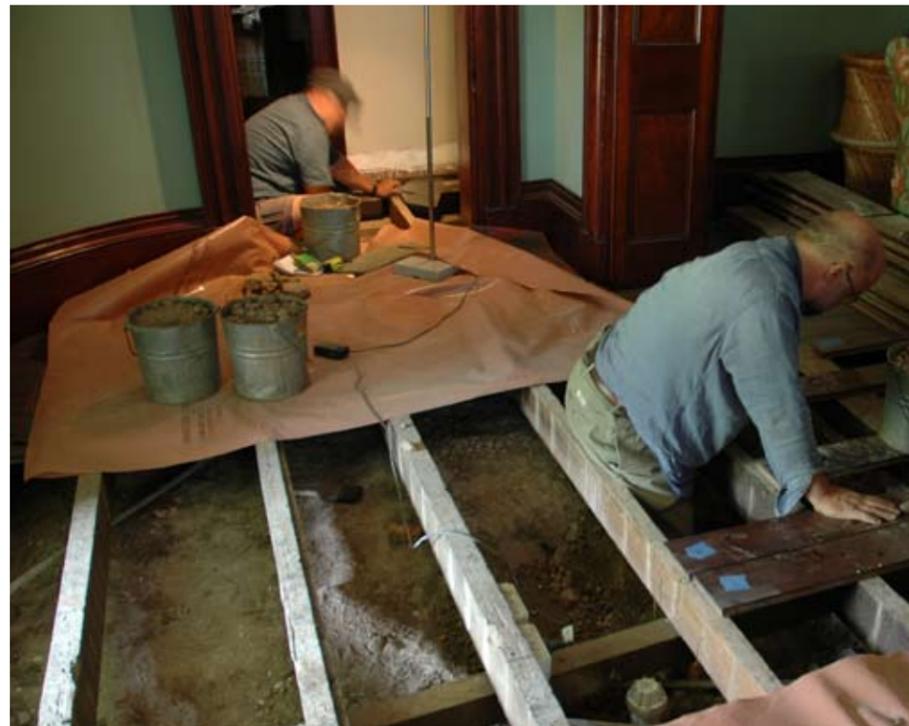
Mortar samples reveal the dating of the surviving structure. The main bedroom (10) and back wall of the hall (14) survive from the 1793 house (shown in yellow). The remainder was rebuilt or constructed in 1826–1827 (pink). The 2007 excavation areas in the drawing room (7) are outlined in red. Arrows point to building joint anomalies.

has been minimal, and limited to maintaining the structure. Since only small portions of the roof space are on public view, wall surfaces did not need to be re-rendered in plaster or made presentable. In December 2007 twelve mortar samples from the main rooms were taken from the roof space, followed by a further nine in February 2008. When the samples were analysed it became obvious that the sequence of building had to be dramatically revised.

What did the mortar samples reveal? The footings of the 1793 drawing room, found by excavation, were bonded with little more than the mud or topsoil found around the house,

and the mortar of the main bedroom was only slightly better. The mortar has no lime or horsehair, traditional means of strengthening the bonding mix. So the mortar, if exposed to the weather, could have easily washed away, leading to collapse of the house. The evidence indicates that possibly soon after construction the outer walls were protected with a stronger, cream-coloured mortar, with shell lime and horsehair added.

But these early or primitive mortar types are only found in the main bedroom and back walls of both the drawing room and the hall. Elsewhere the mortar type is totally different – a good quality shell lime and horsehair mortar, salmon pink in colour. What is even more surprising is that this mortar is found in the remaining walls of the main rooms, plus all the 1826 extensions. The most likely explanation is that the main rooms, with the exception of the main bedroom, were largely rebuilt in 1826 and 1827, along with the extensions to the house. We can now understand why James Macarthur wrote on 17 May 1827 that 'the roof alone remains of the Cottage it formerly sheltered'.² It would seem the 1793 roof was propped up while the front and side walls of the main rooms were rebuilt, with French doors replacing the original small windows.
